HISTORIC AMERICAN BUILDINGS SURVEY
INVENTORY

2. NAME *Orrin Thompson Mansion*

DATE OR PERIOD *1832*
STYLE *Greek Revival*
ARCHITECT
BUILDER *Orrin Thompson*

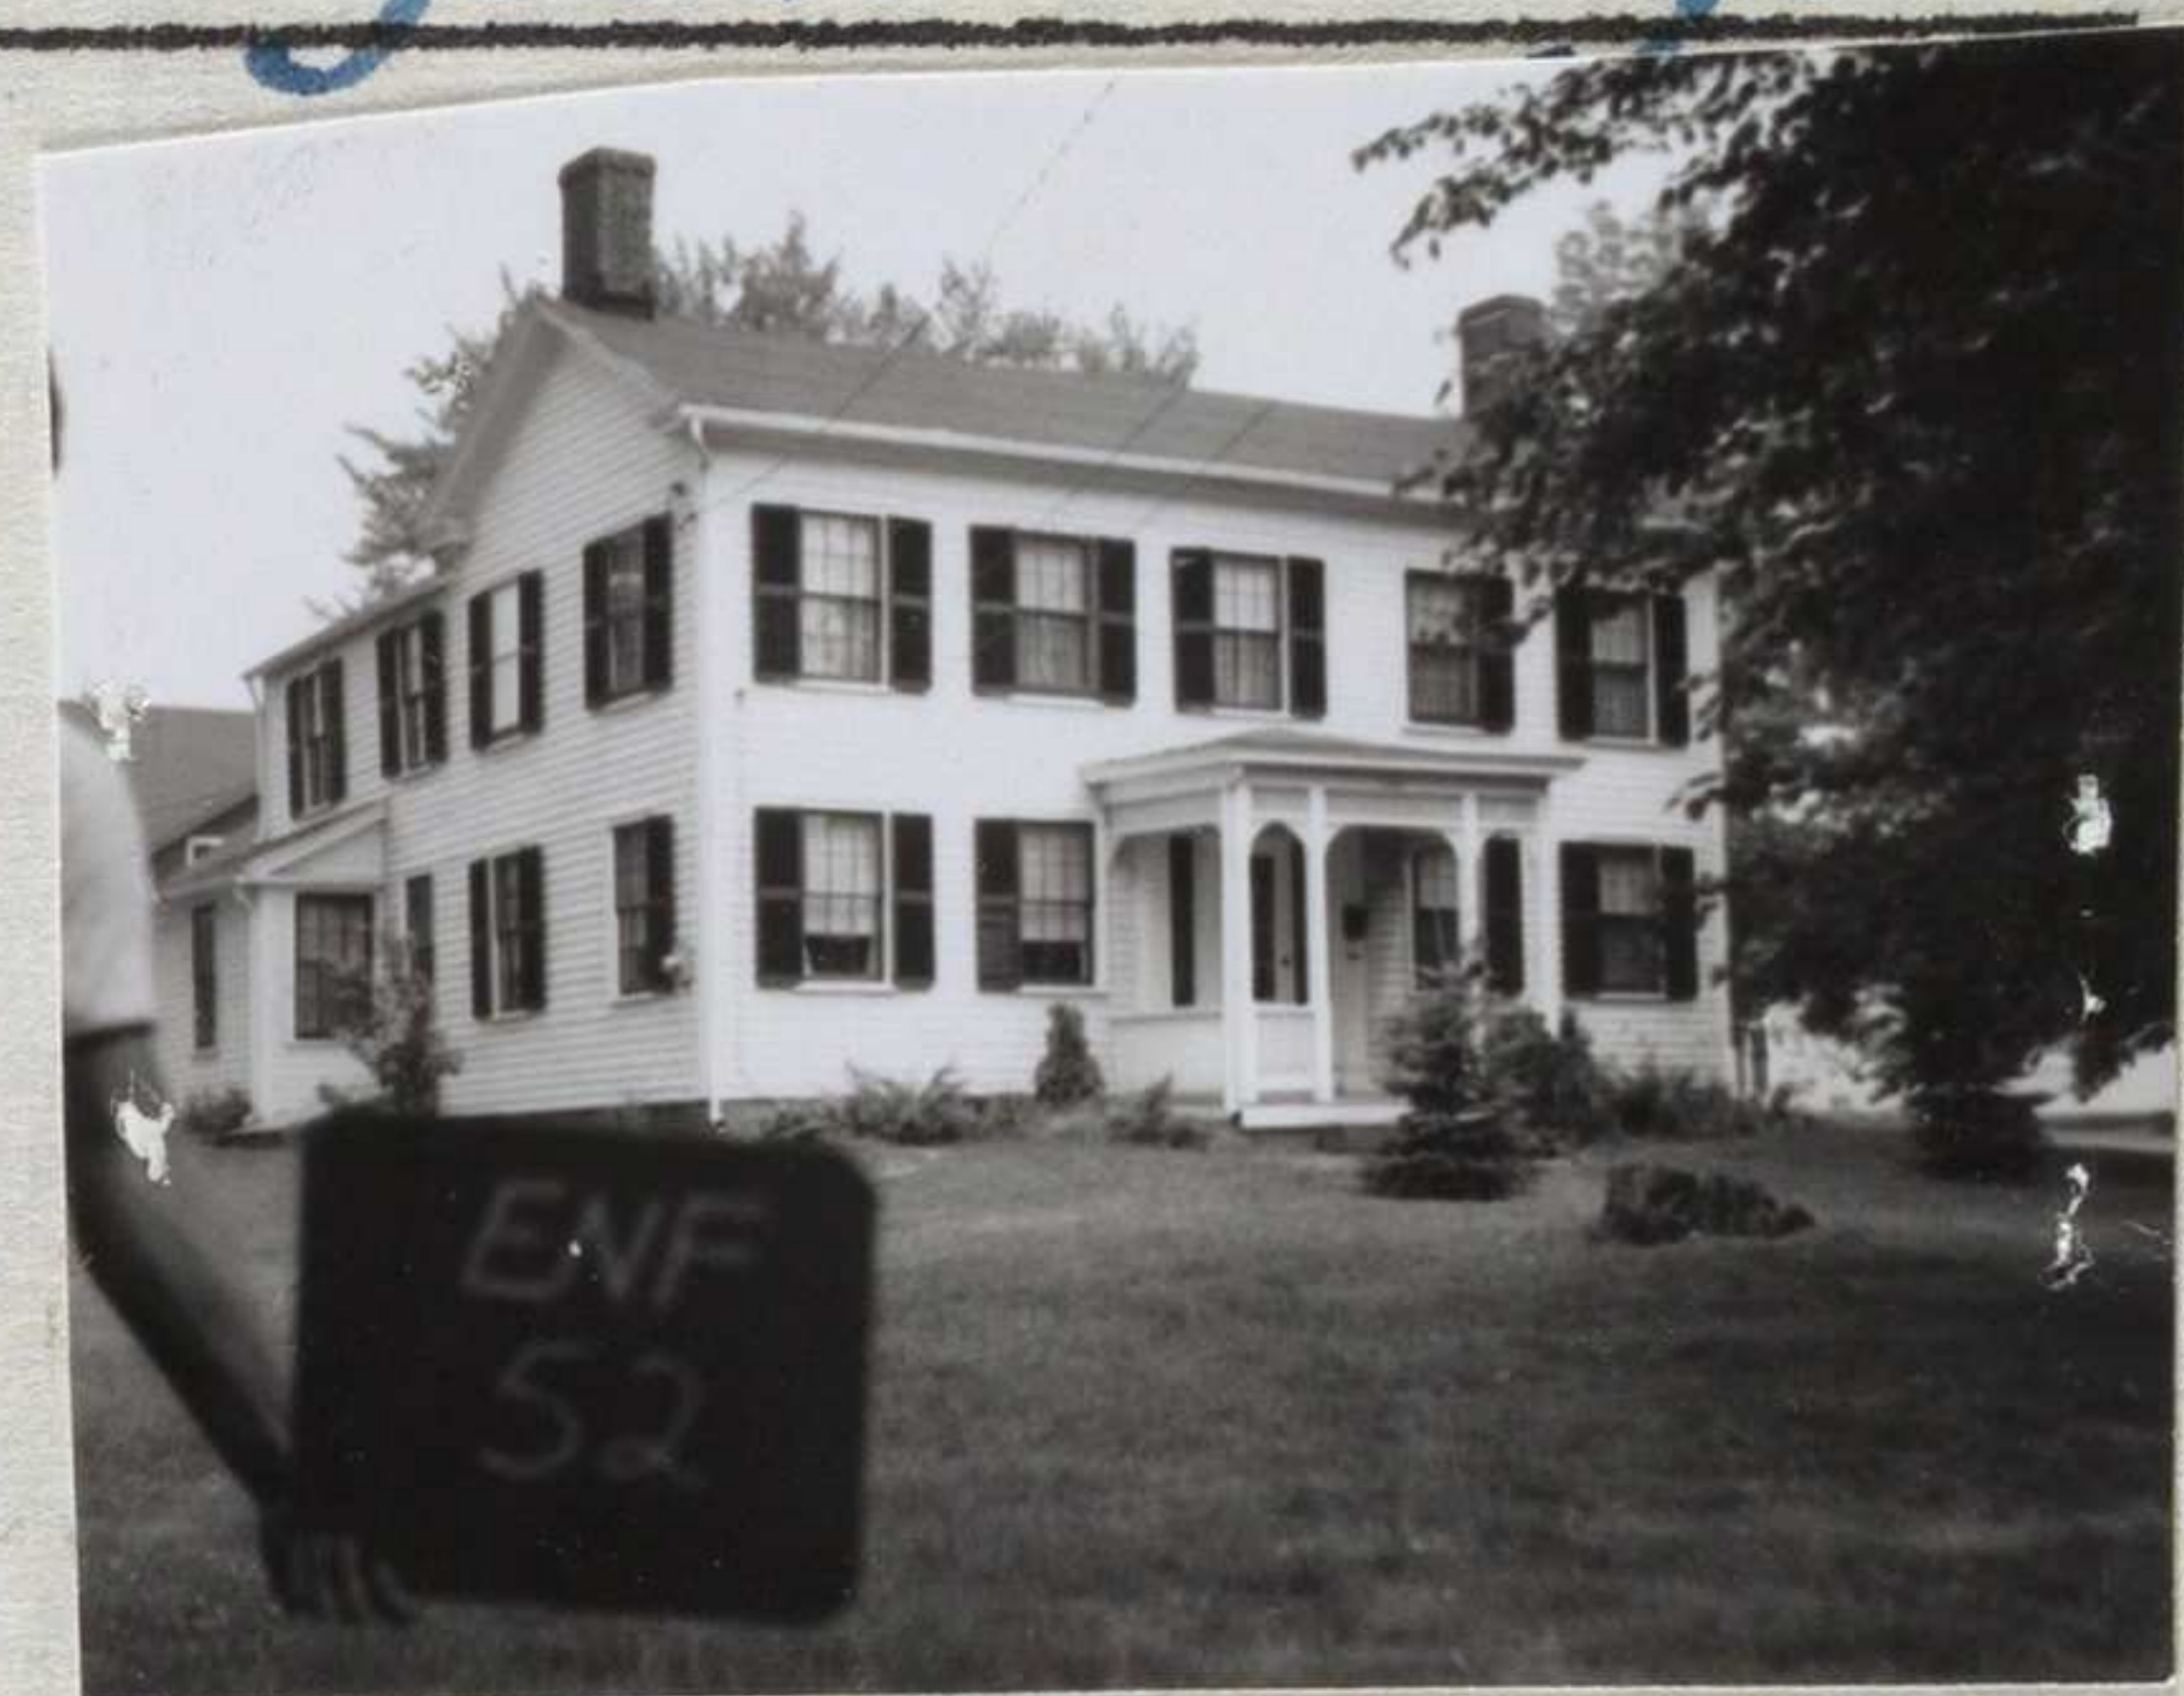
7. PHOTOGRAPH *Enf 552**

According to accurate records this house was built in 1800, it looks later. Built upon a brick foundation this five bay house has a very narrow depth and a shallow pitched roof. There are ⁽²⁾ two chimneys located at the end of the gables. The two southern bays are just a bit wider than the others, perhaps suggesting their addition. One addition is sure, an ell to the rear. The doorway is a fine early 19th century affair. The door itself is unfortunately new.

Endangered *No.* Interior *good?* Exterior *good*

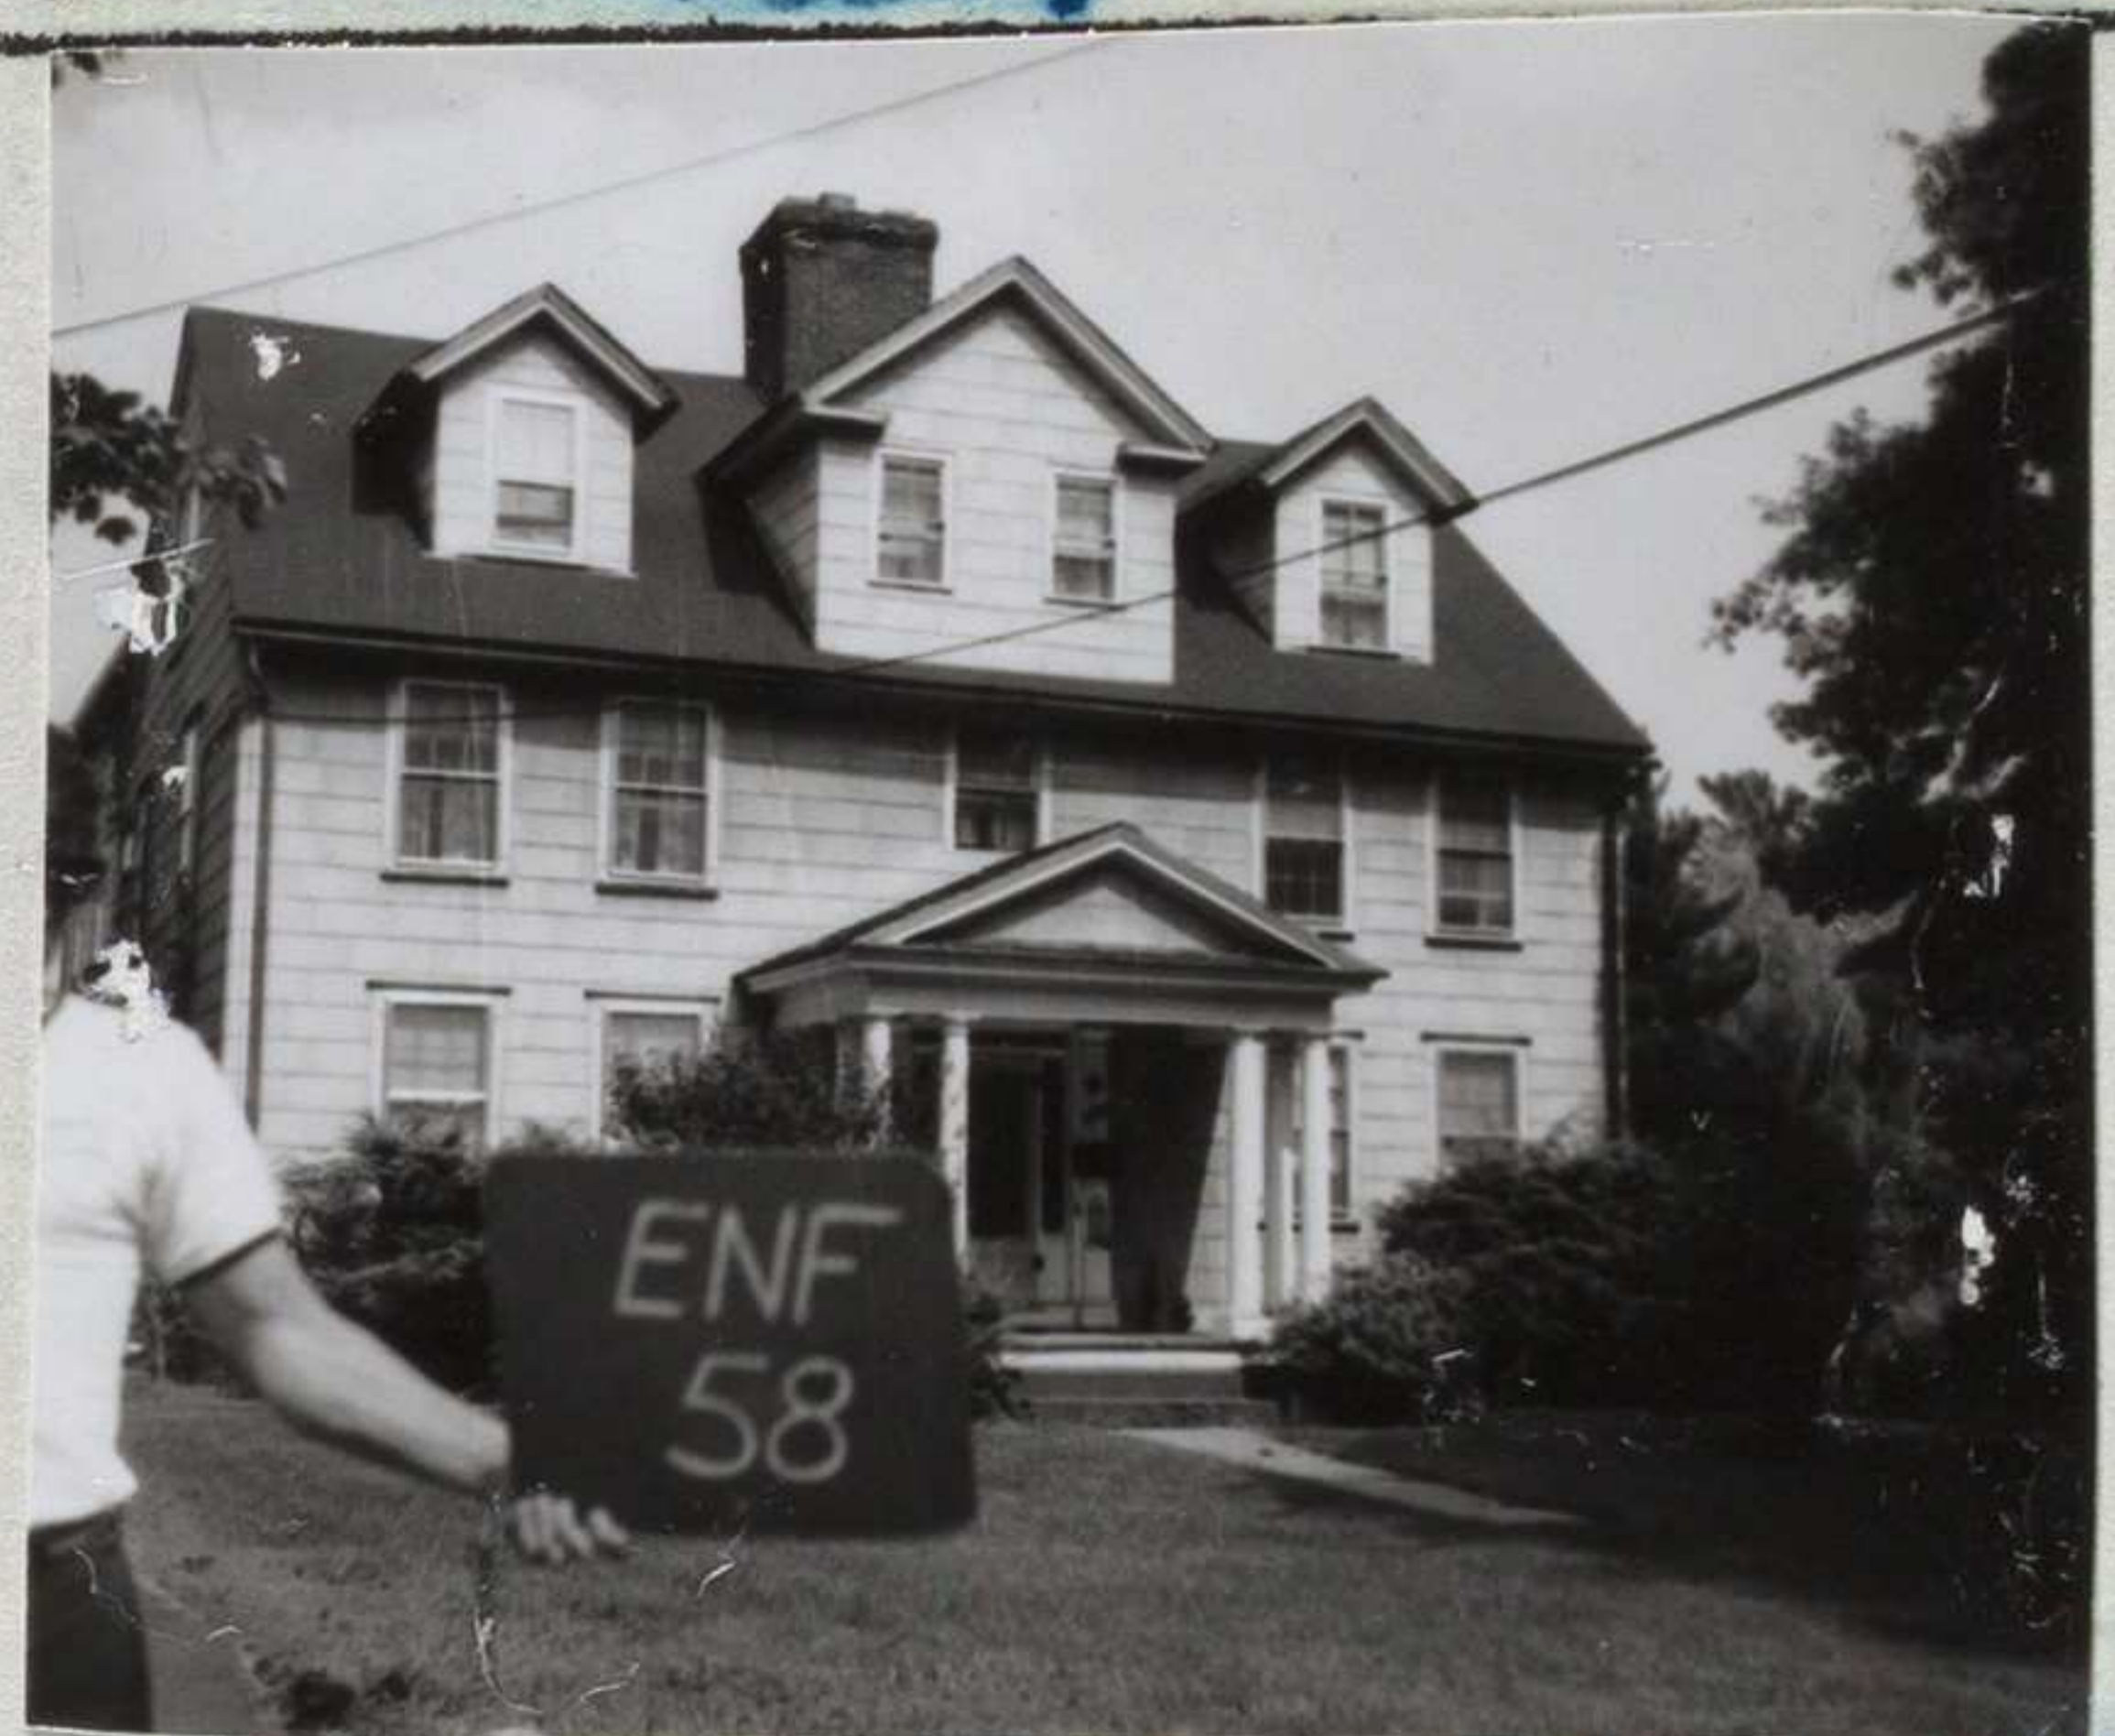
7. PHOTOGRAPH *Enf 58*

This old house has been left in rather sad condition due to the "improvements" of many years. Constructed on a brownstone foundation like most of the buildings of its period, the house has a high (40°) pitch and its original huge chimney. There are five bays and the original windows, ^{in a few cases} mercifully remain. A 19th century door with sidelights fits the original double doorway. The 1920's, however, have added such travesties as huge dormers, double windows, a masking porch, and a three-story addition to the rear. Johns-Mansville shingles have lately finished the harm these alterations began.

Endangered ? Interior *Poor?* Exterior *Poor*

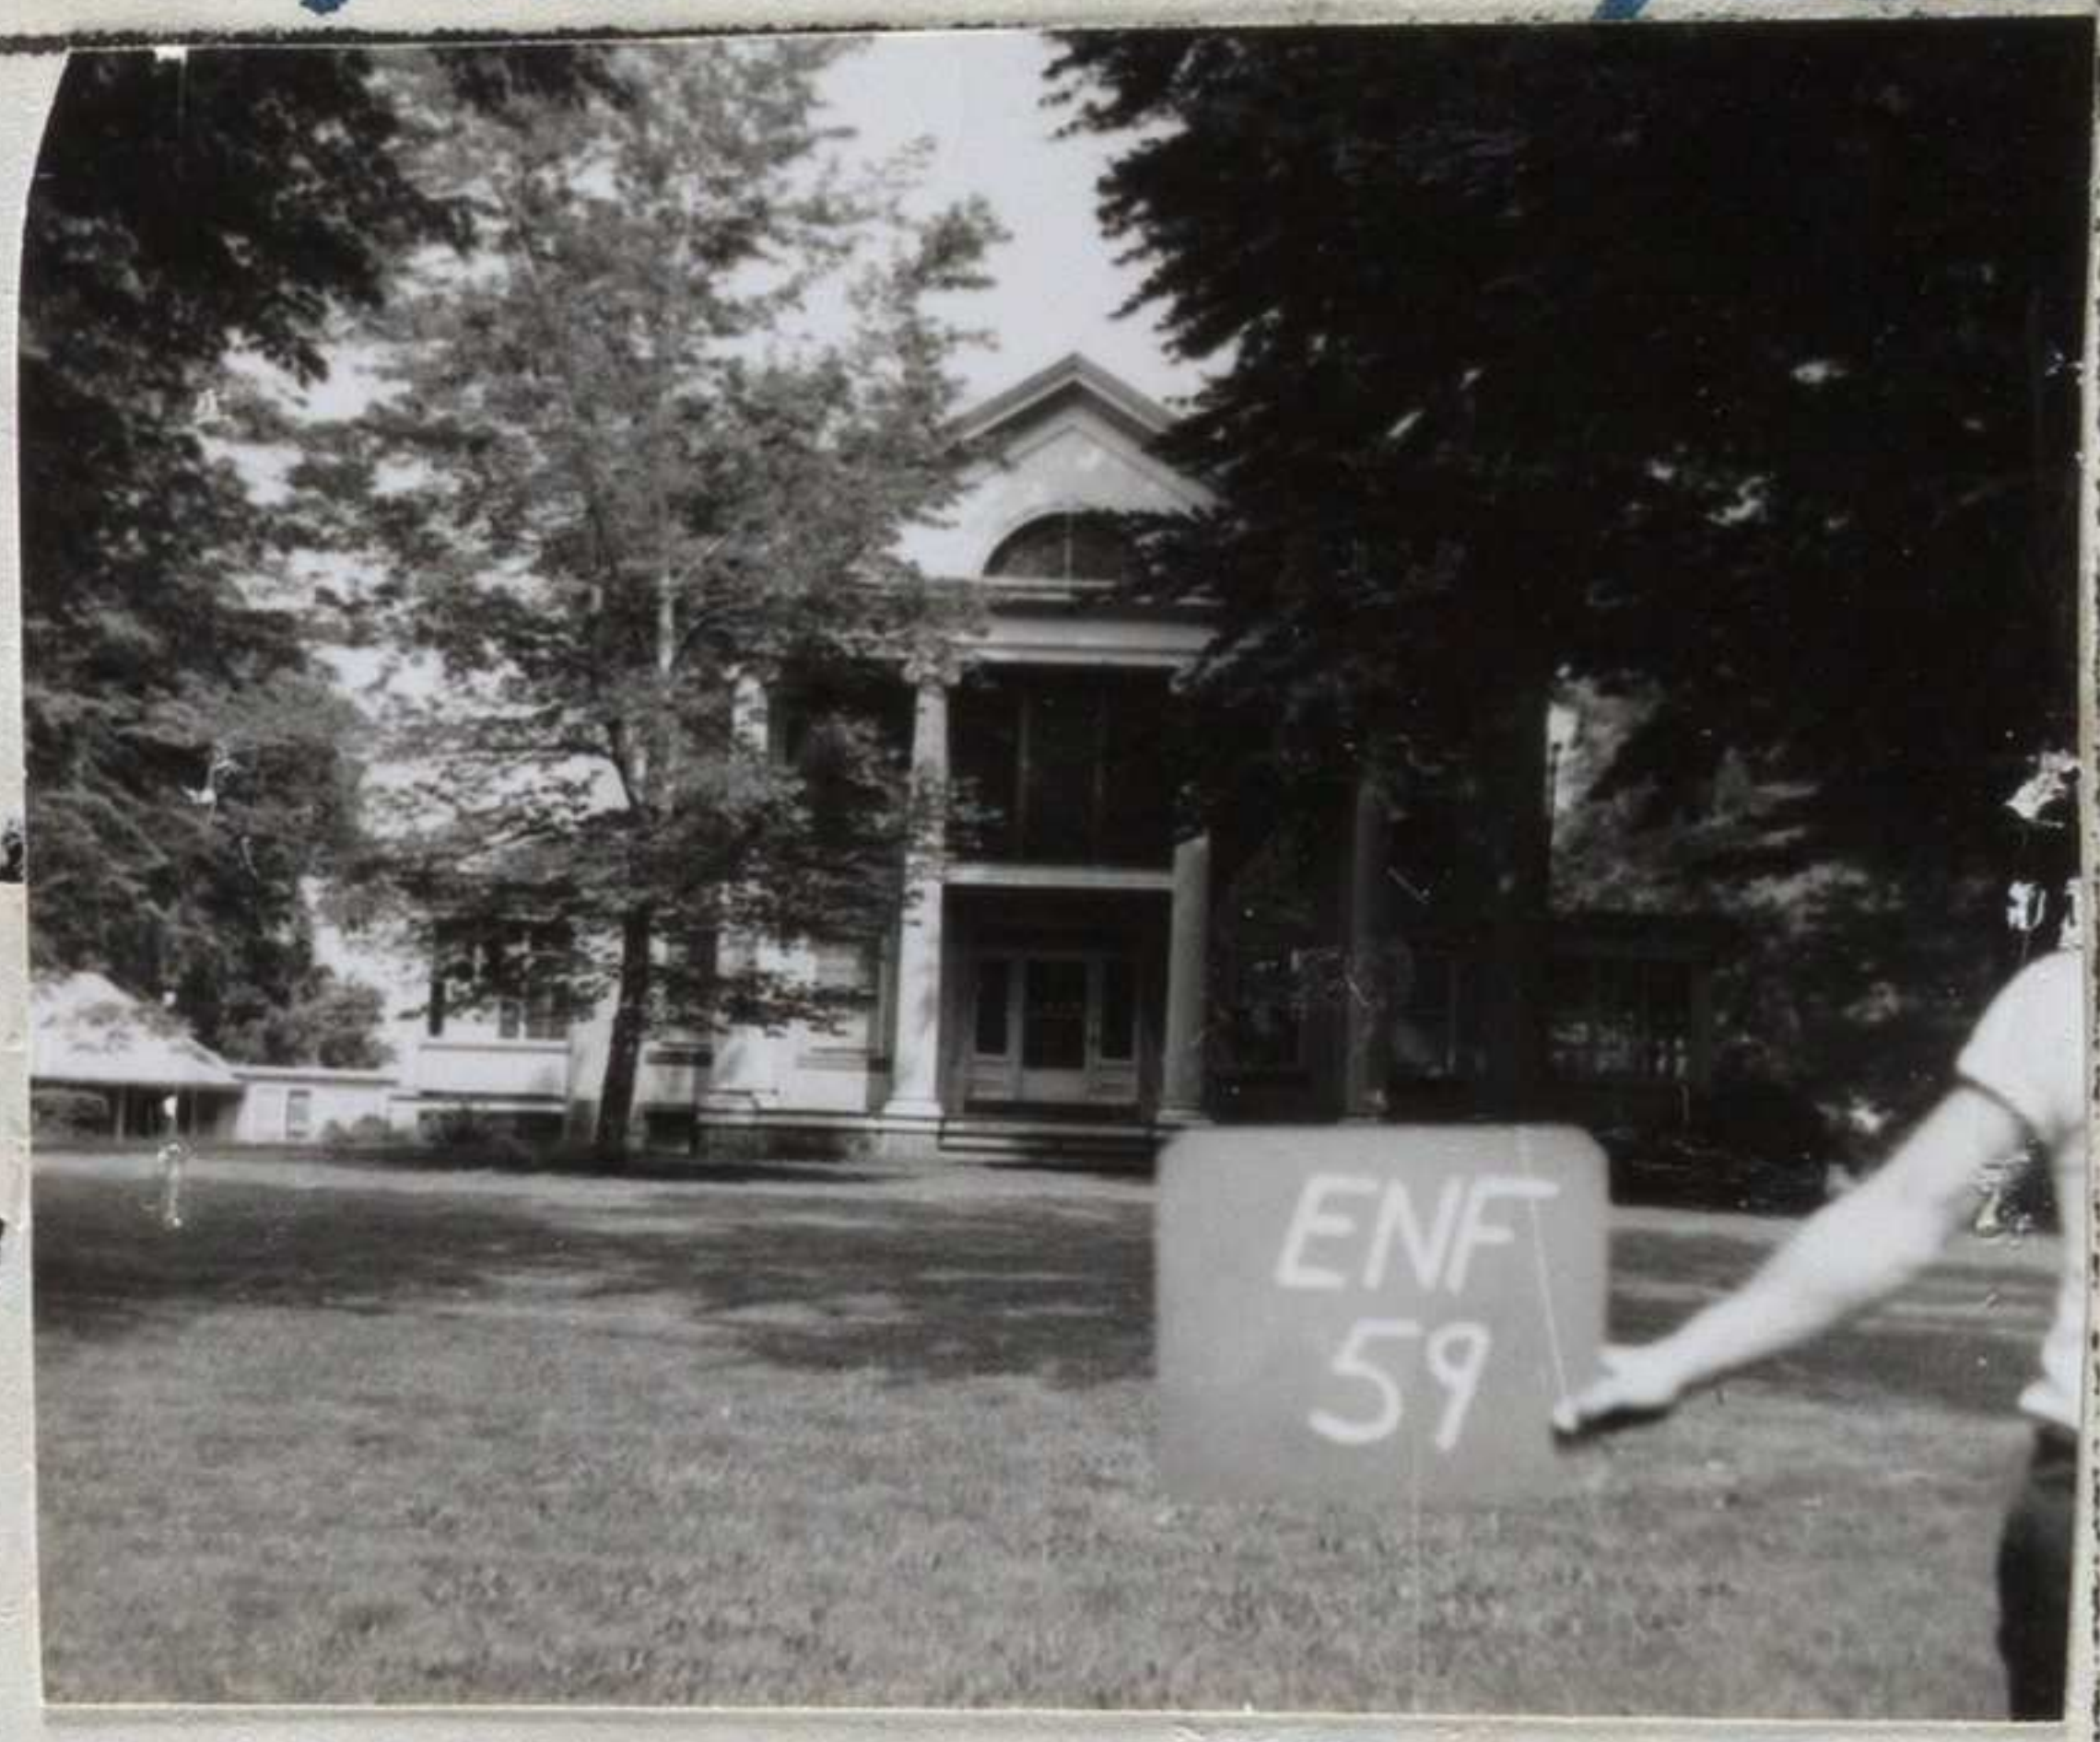
<div>5. PHYSICAL CONDITION OF STRUCTURE Endangered ? Interior <i>Fair?</i> Exterior <i>good</i></div>		<div>7. PHOTOGRAPH <i>Enf 59</i></div>

<div>1. STATE <i>CT</i> COUNTY <i>Hartford</i> TOWN <i>Enfield</i> VICINITY STREET NO. <i>1221 Enfield Street</i> ORIGINAL OWNER ? ORIGINAL USE <i>Residence</i> PRESENT OWNER ? PRESENT USE <i>Residence</i> WALL CONSTRUCTION <i>stucco</i> NO. OF STORIES <i>2</i></div>		<div>HISTORIC AMERICAN BUILDINGS SURVEY INVENTORY</div> <div>2. NAME DATE OR PERIOD <i>1920</i> STYLE <i>classic example</i> ARCHITECT BUILDER</div> <div>3. FOR LIBRARY OF CONGRESS USE</div>	
<div>4. NOTABLE FEATURES, HISTORICAL SIGNIFICANCE AND DESCRIPTION <i>This house is almost not in on this list. It was built in the 20's, a period with very little grace for our eyes at present, yet it has a charm even in its overly extravagant and inexact proportions. The five bay stucco dwelling is built on a brownstone foundation, the central three bays are marked by an Ionic portico. The pediment of this portico, formed by a shallow pitched roof, is punctuated by a semi-circular window. Double chimneys break the ridge line and porches extend the sides. The doorway is very poor, being a great deal too wide.</i></div>		<div>OPEN TO PUBLIC <i>No.</i></div>

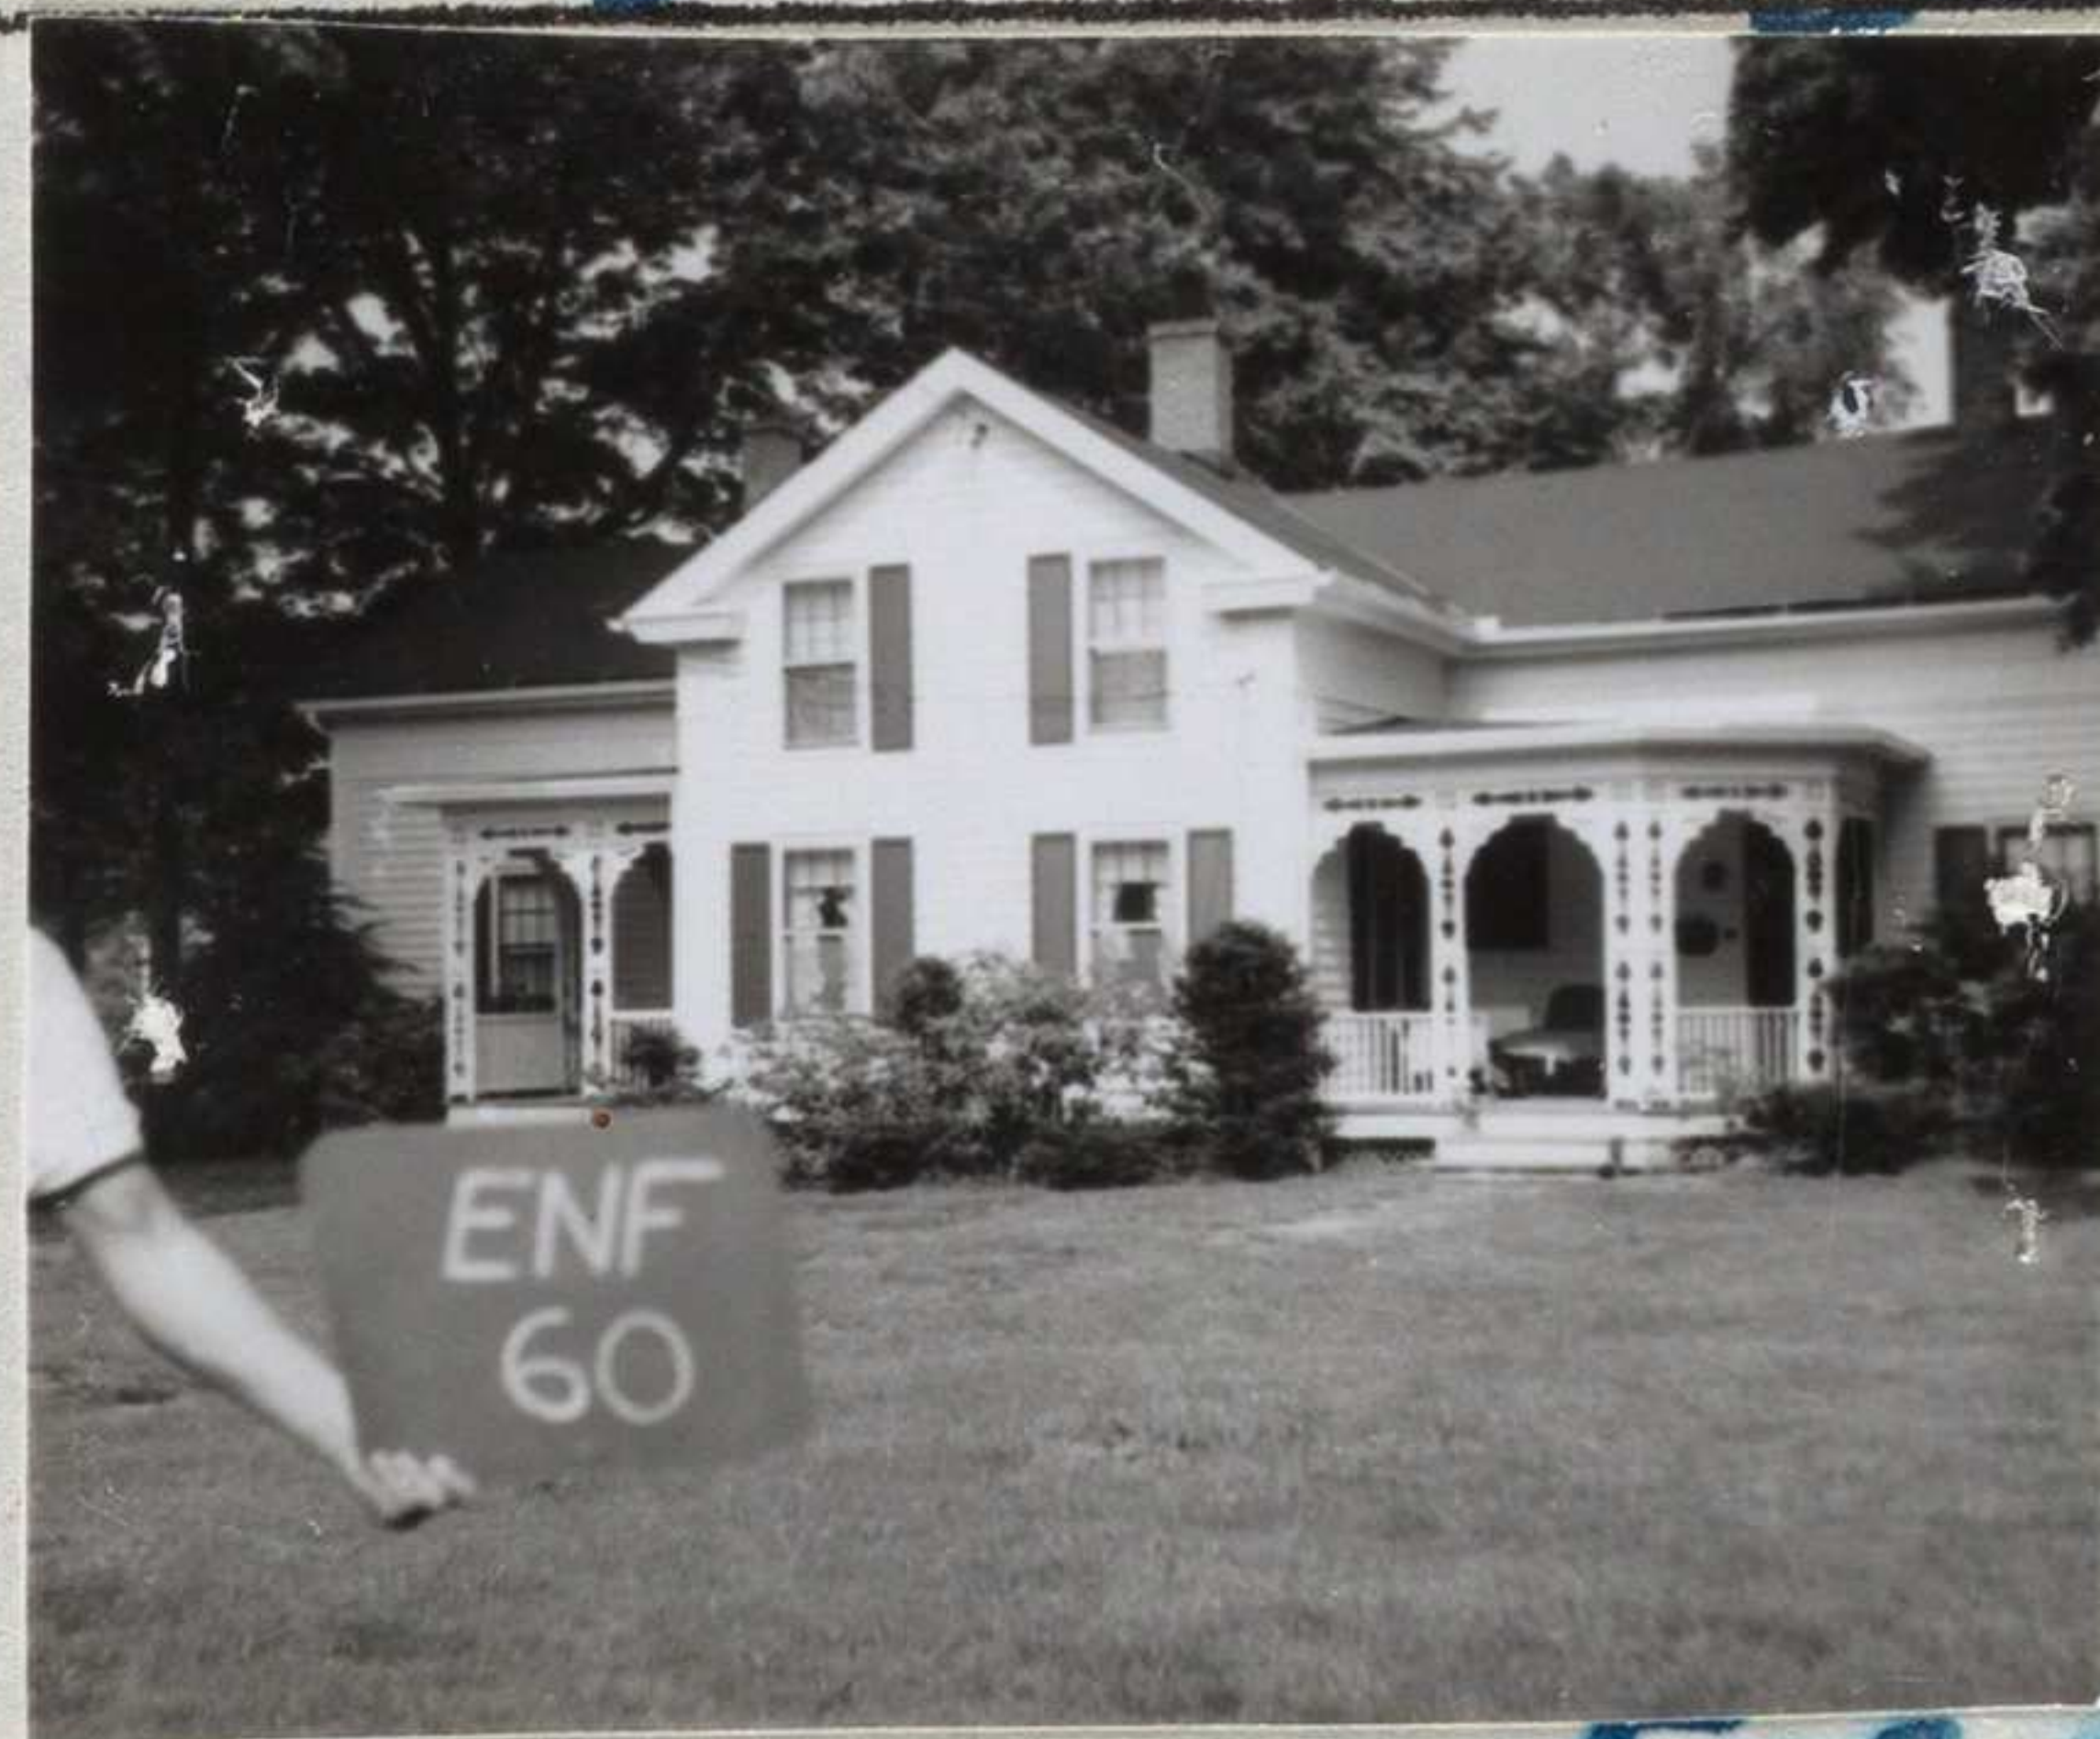
7. PHOTOGRAPH *Enf 60*

This house may have begun as a very simple Greek Revival house but the carpenter Gothic porches which decorate its facade has completely changed its character to a structure of whimsy. The 1 1/2 story house is in a T shape, with a wide plain entablature. To the rear is a quite old lean to and other additions have also made themselves shown. The house is built upon a brick foundation and capped with a shallow pitched roof. The windows are original of the 6/6 variety.

Endangered *P* Interior *fair?* Exterior *good*

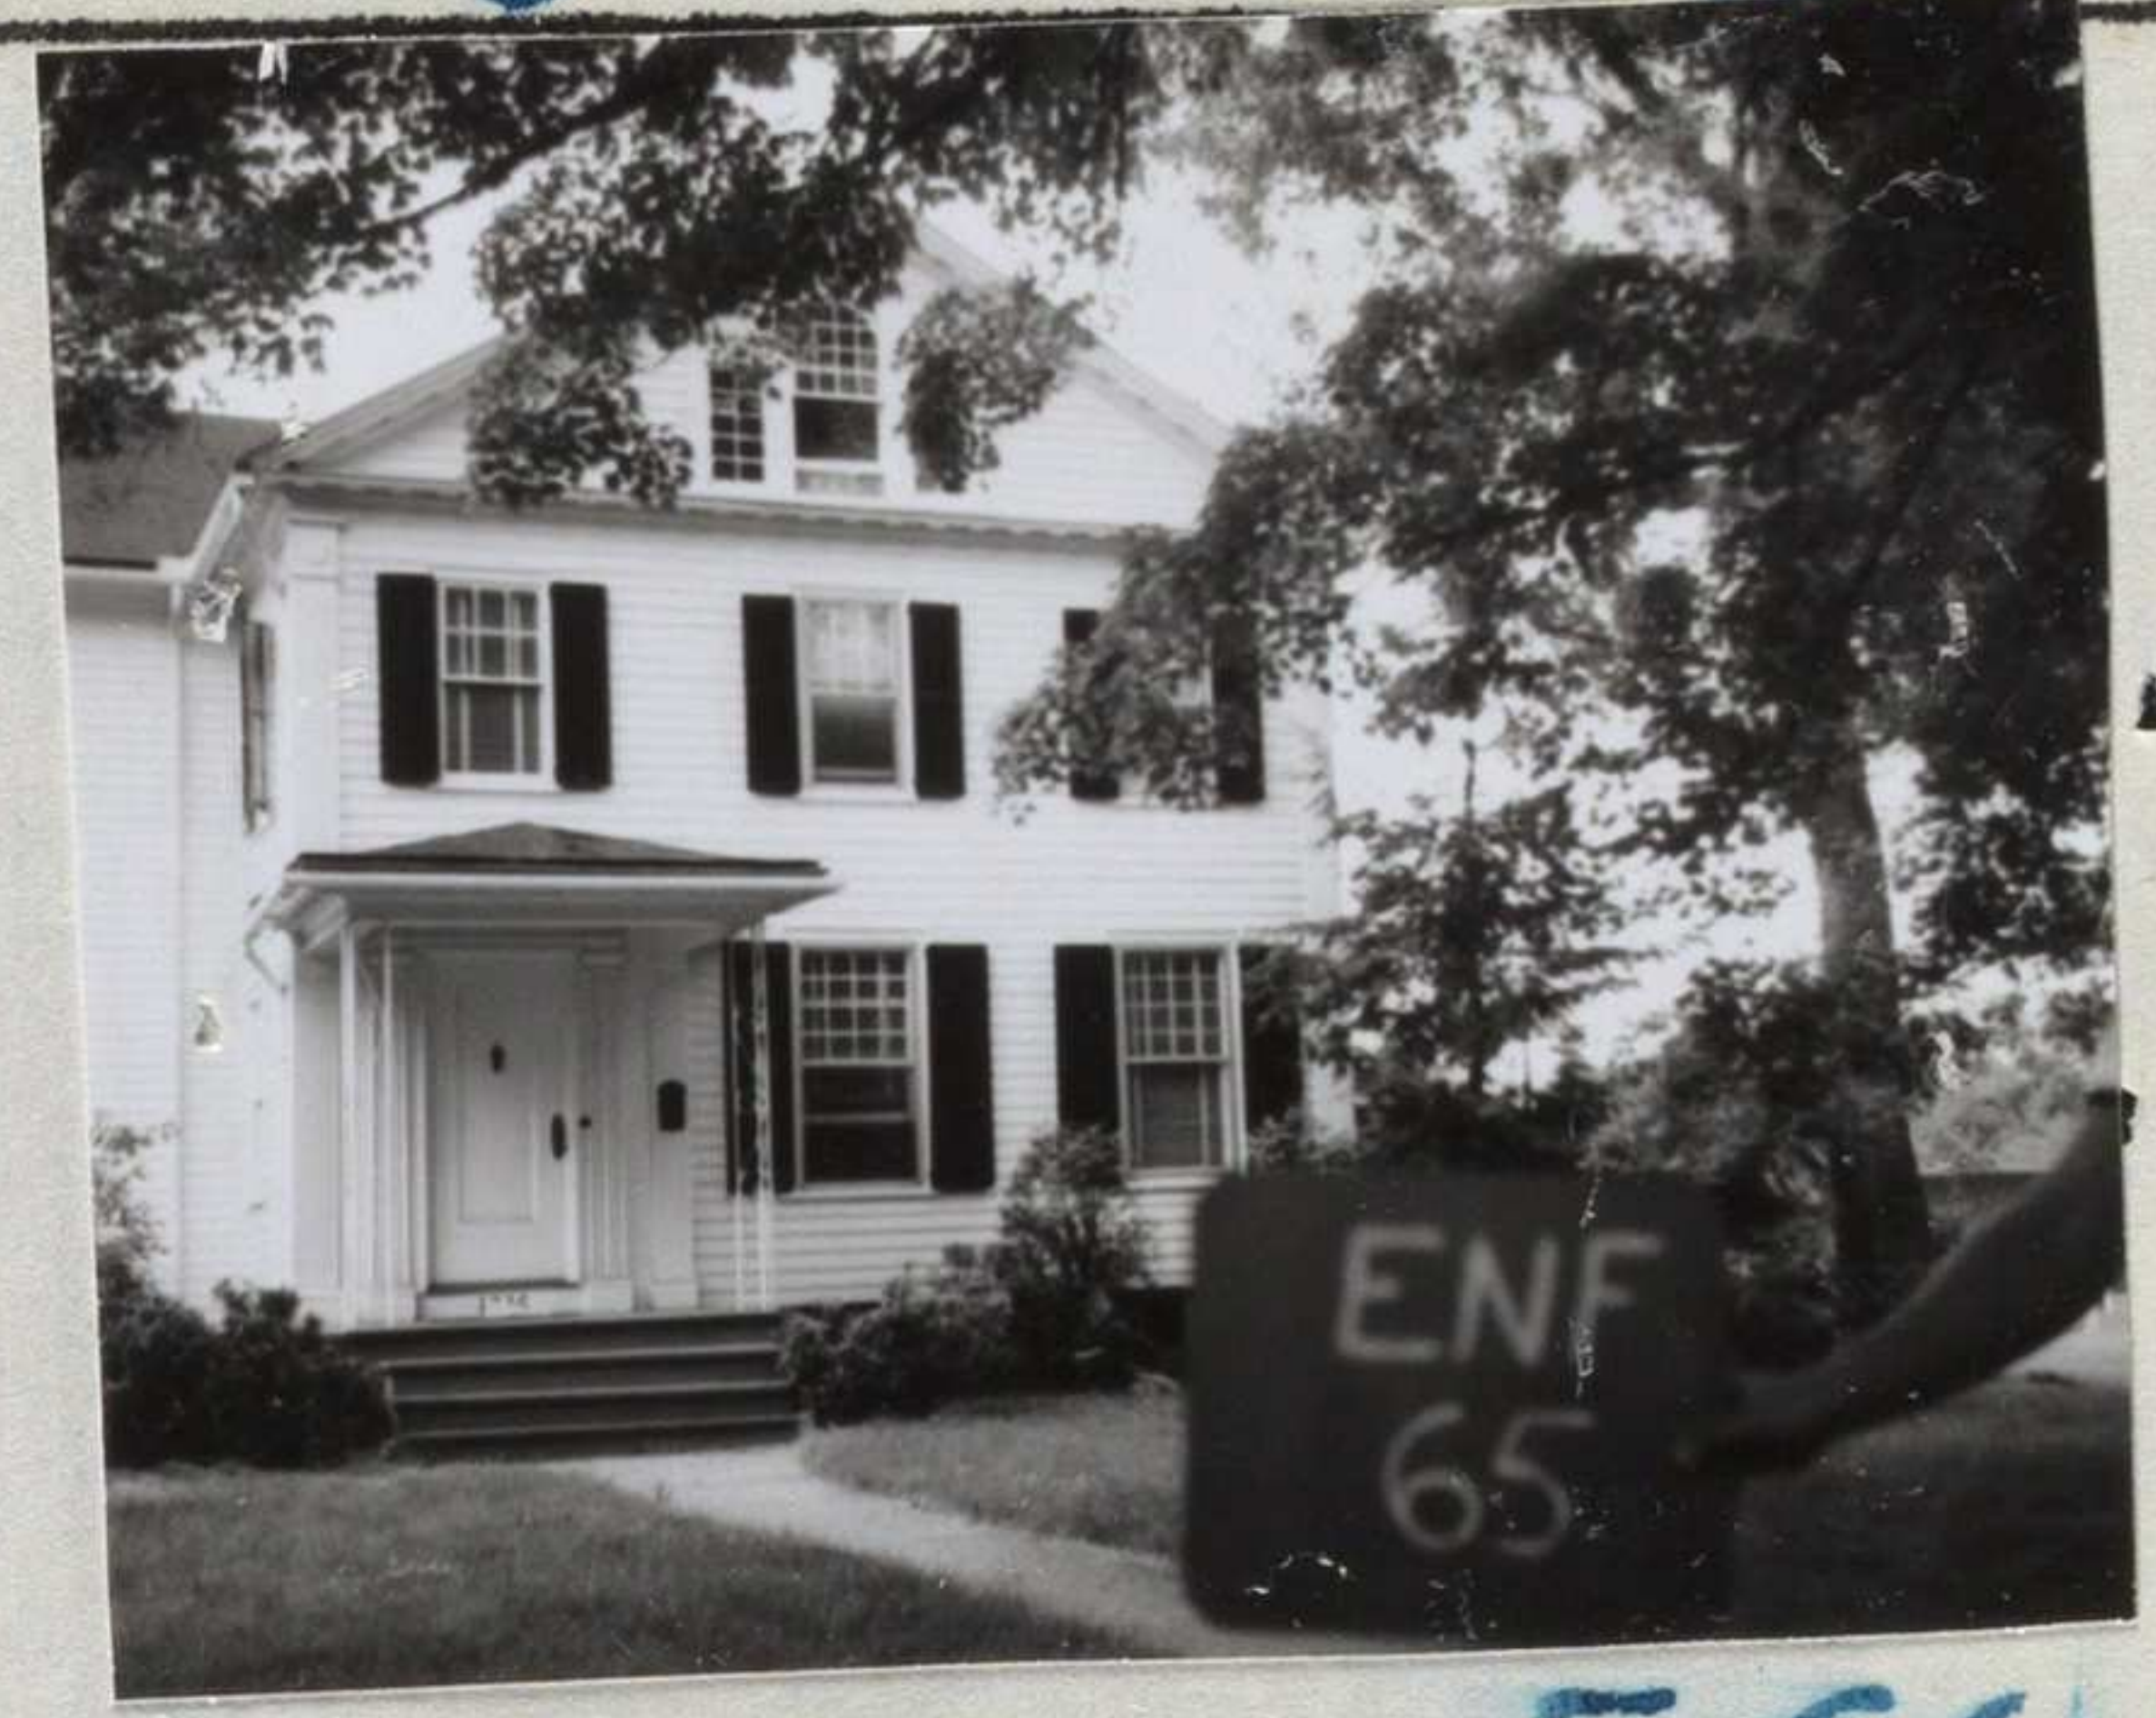
<p>7. PHOTOGRAPH <i>Enf 65</i></p>

<p>1. STATE <i>CT</i> COUNTY <i>Hartford</i> TOWN <i>Enfield</i> VICINITY STREET NO. <i>1226 Enfield St.</i></p> <p>ORIGINAL OWNER? ORIGINAL USE <i>Residence</i> PRESENT OWNER? PRESENT USE <i>Residence</i> WALL CONSTRUCTION <i>clapboard</i> NO. OF STORIES <i>2</i></p>	<p>HISTORIC AMERICAN BUILDINGS SURVEY INVENTORY</p> <p>2. NAME</p> <p>DATE OR PERIOD <i>1800?</i> STYLE <i>Federal</i> ARCHITECT BUILDER</p> <p>3. FOR LIBRARY OF CONGRESS USE</p>
<p>4. NOTABLE FEATURES, HISTORICAL SIGNIFICANCE AND DESCRIPTION</p> <p>OPEN TO PUBLIC <i>No</i></p> <p><i>This house has, according to its present owner, been moved. It is in three bays built on its present brick foundation. Its shallow pitched roof forms a pediment which has a new ill-placed palladian window. The first floor windows are also new and a large Southern wing is a further alteration. The corner pilasters are fluted but probably modern. The cornice is rich in dentils with incized guttae. Under an unfortunate added front porch there is a doorway almost exactly like those of the old Post Office and House #69. Unlike the post office but like #69 the doorway pilasters have irregular moldings, but the same recessed ovals in the entablature of these pilasters occur in all three.</i></p>

<p>5. PHYSICAL CONDITION OF STRUCTURE</p> <p>Endangered <i>No</i> Interior <i>fair?</i> Exterior <i>fair</i></p> <p><i>Enfield Street</i></p> <p><i>Green Valley Dr.</i></p>
